Adhesion of Restorative Materials

By Gregg A. Helvey, DDS

CASE REPORT

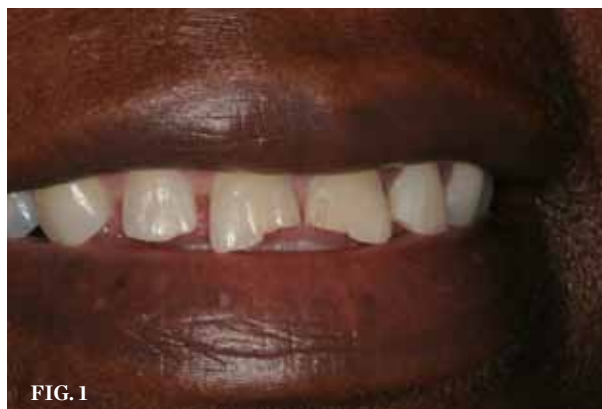
(1.) Frontal view of the fractured central incisors and diastemas present in the remaining anterior teeth. (2.) After placement of the B-1 Prodigy composite mock-up, the patient was able to evaluate the proposed treatment for esthetics, phonetics, and function. (3.) OptiBond XTR primer was applied using a scrubbing motion for 20 seconds for each tooth. It is important to use a new drop of primer for each tooth. (4.) OptiBond XTR primer was air-thinned for 5 seconds. (5.) Using a brushing motion, OptiBond XTR adhesive was applied to each tooth for 15 seconds. (6.) OptiBond XTR adhesive was air-thinned for 5 seconds. (7.) The treated teeth were each light-cured for 10 seconds.

A 46-year-old patient presented with fractured incisal edges on her maxillary central incisors (Figure 1). She wanted her teeth restored and the spaces between the other maxillary anterior teeth closed. After discussing the risks and benefits of several treatment options, the decision was made for placement of six anterior ceramic laminate veneers. Duplicate study models were poured and a mock-up was created in the laboratory. On the next appointment, using a vacuum-form stent filled with shade B-1 Prodigy (Sybron/Kerr), the mock-up was transferred onto the patient's maxillary anterior teeth. After finishing and polishing the additive mock-up, the patient was dismissed (Figure 2). One week later, she reported that she was happy with the esthetics and phonetics and had no problems with speech or chewing (function). At the preparation appointment the teeth were prepared using the "round-bur preparation technique," and after completing impressions, face-bow transfer, and bite registration, the provisional restorations were placed using the same mock-up material and stent.

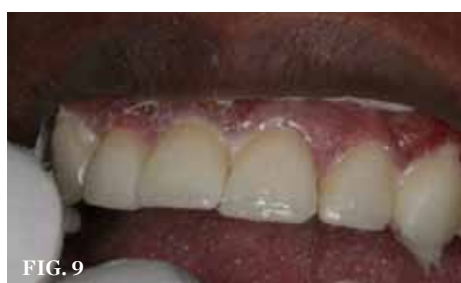
(8.) The restorations were filled with Nexus 3 light-cure and placed all at once. **(9.)** A cotton roll was used to remove the gross excess cement. **(10.)** The two central incisor restorations were firmly held in place then exposed to the curing light for 5 seconds. The same procedure was repeated for the lateral and canine restorations. **(11.)** Retracted view of the final restorations in place. **(12.)** Facial view of the finished restorations.

tooth (Figure 8). After all the restorations were in place, a cotton roll was used to remove the gross excess cement (Figure 9). Taking hold of the two central incisor restorations with the index finger and thumb, the clinician held them firmly into place and then exposed them to the curing light for 5 seconds (Figure 10). The positioning of the hands blocked the adjacent restoration from any light exposure. Next, the two lateral incisors were held in a similar fashion and light-polymerized for 5 seconds.
